Under certain circumstances, a vacuum interrupter may fail after placed back in service due to saltwater exposure.

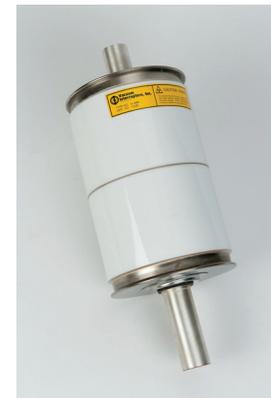
External view of typical vacuum interrupter.

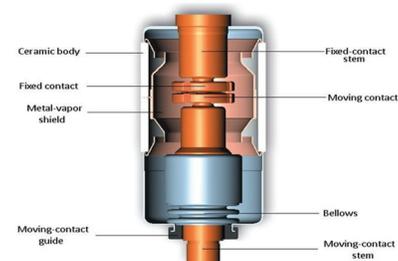
Cutaway drawing of typical vacuum interrupter.

Vacuum interrupters are designed with metal bellows to allow movement of one of the two contacts. Typically, these bellows are made of an austenitic stainless steel and have a thickness of only a few thousandths of an inch. Under ideal conditions, the mechanical life of the bellows can range from 10,000 operations for vacuum circuit breakers and recloses to 106 operations in vacuum contactors. However, there are numerous factors which can severely reduce the mechanical life of the bellows including corrosion caused by exposure to saltwater.

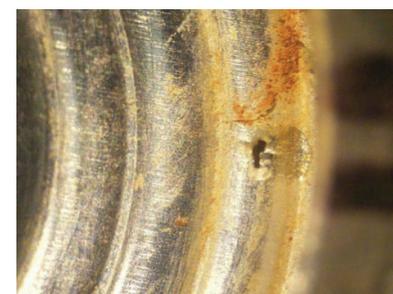
Corrosion in stainless steel bellows comes in two main forms: galvanic and chloride corrosion. Galvanic corrosion occurs as a result of two dissimilar metals being in contact with each other in a conducting, corrosive environment [2]. For example, the stainless steel bellows and copper-based brazing material in a vacuum interrupter will experience galvanic corrosion after being exposed to saltwater (Figure 2). Galvanic corrosion is observed as pitting in the materials. The driving force of galvanic corrosion is the differential voltage between the two materials.

Figure 1. Galvanic corrosion in stainless steel bellows.

One of the best 300-series stainless steels is type 316. Even this alloy will, if unprotected, start corroding under soft washers, in o-ring grooves, or any other tight crevice area in as little as one day, and it is not unusual to have penetration of a tenth of an inch in a crevice area after only 30 days in seawater. If water flows fast past a stainless steel, more oxygen is delivered to the stainless steel and it corrodes less. For this reason, stainless steels have been successfully used for impeller blades and propellers. These need to be protected from corrosion when there is no flow (Figure 1).

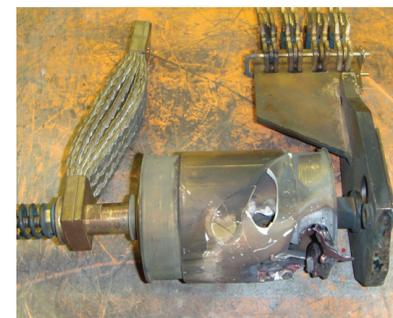
Failure of the bellows in a vacuum interrupter will result in loss of vacuum. Without a proper vacuum, a vacuum interrupter will not be able to properly insulate the applied voltage, possibly resulting in catastrophic failure. If vacuum circuit breakers have been exposed to saltwater, whether partially or fully, the mechanism should be properly reconditioned, or preferably replaced.

Figure 2. Vacuum interrupter exposed to salt water then placed back into service failed catastrophically 180 days later.
